Benthic Habitat Characterization Survey

George Town Harbor Berthing Program

DOCUMENT NO. CSA-WIM-FL-15-1904-2890-01-REP-01-FIN-REV01

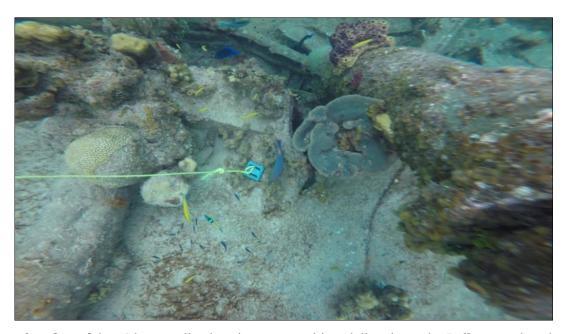
Image 3. One of the 61 bounce dive locations was positioned directly on the *Balboa* wreck and was subsequently classified as a man-made artifact.

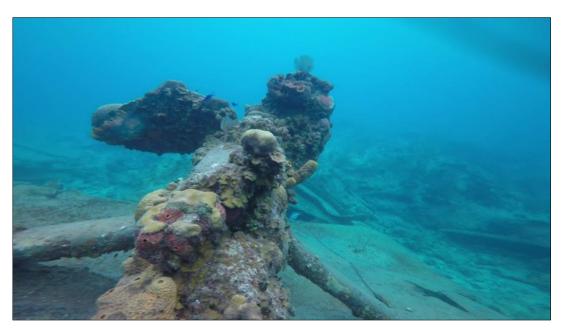
Image 4. Portions of the submerged *Balboa* wreck supported a biological community that included corals.

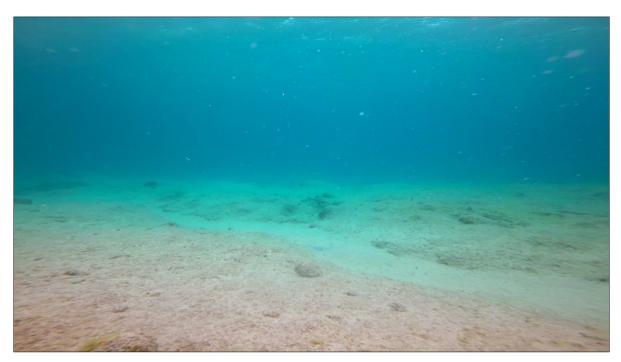
Hard bottom with sand veneer habitat classification was applied to low-relief carbonate substrate which was overlaid by unconsolidated substrate in highly variable amounts (**Image 6**). The variable thickness of the sand veneer and relatively level topography appear to have limited the amount of epibiotic development on this habitat classification (**Image 7**). This habitat had relative distributional continuity along the shoreward central portion of the berthing program's projected direct impact area (**Figure 3**).

Image 6. Hard bottom with sand veneer habitat classification was applied to low-relief carbonate substrate, which was overlaid by a covering of unconsolidated substrate.

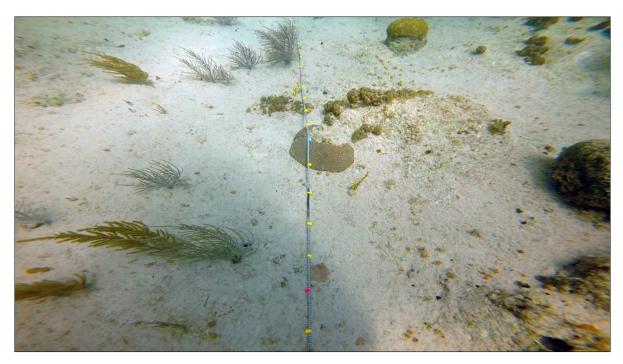
Image 7. The hard bottom with sand veneer habitat with low-relief topography appeared to have limited epibiotic development.

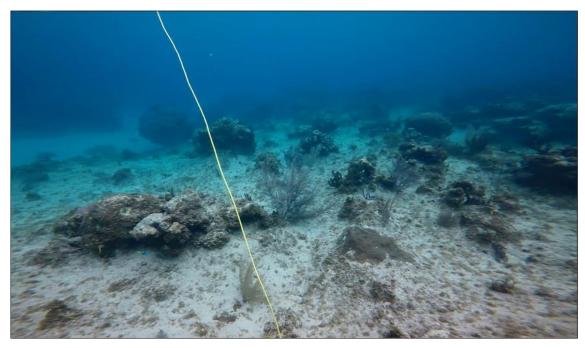
Exposed reef formation classification was applied to irregular relief carbonate substrates that supported a relatively productive epibenthic community with a relative high diversity and abundance of corals. The exposed reef formation habitat is characterized by elevated topographic features, which are primarily a product of hermatypic coral deposition and subsequent disproportional erosion of these deposits (**Image 8**). The irregular topography of the areas classified as exposed reef formation provides elevated substrate and considerable microhabitat (**Image 9**), which visually distinguishes it from the hard bottom with sand veneer habitat.

Image 8. The exposed reef habitat is characterized by elevated topographic features, which are primarily a product of hermatypic coral deposition.

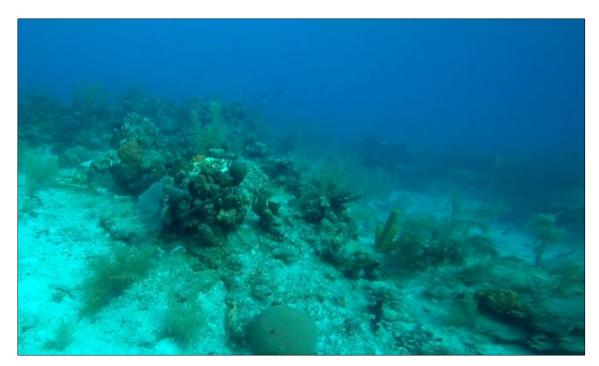
Image 9. Irregular topography observed in the exposed reef formation habitat, which provides elevated substrate and considerable microhabitat.

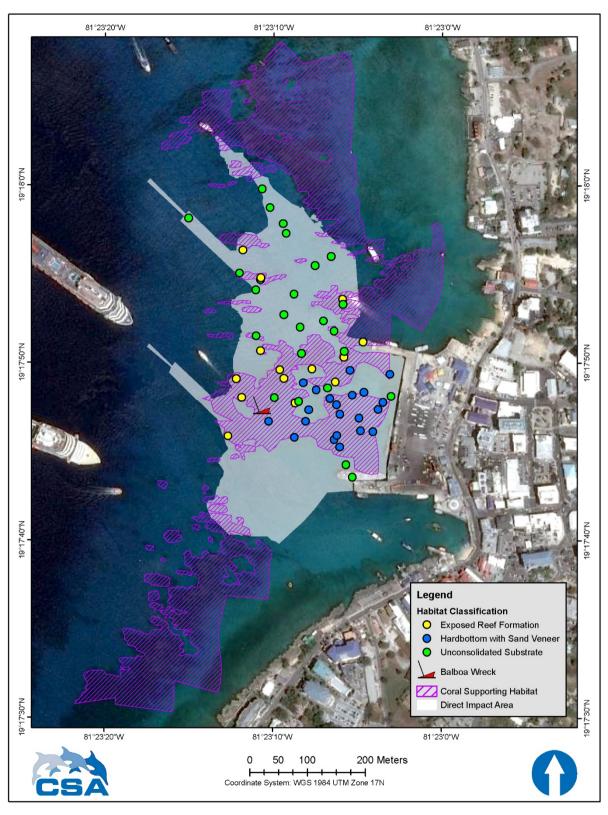
Exposed reef formation habitat (shown in yellow dots in **Figure 6**) had irregular and relatively high topographic relief that supported a productive epibenthic community with 22 observed hard coral taxa (**Image 11**). Coral densities for the exposed reef formation habitat ranged from 7.6 to 15.2 colonies m⁻² of hard corals and from 0.1 to 5.3 colonies m⁻² of soft corals. Although the exposed reef formation habitat was dominated by smaller corals, with 34.2% of hard corals greater than 10 cm and considerable populations of larger soft corals (>25 cm in height) suitable for translocation, the coral community characteristics of this habitat would facilitate efficient and productive coral translocation efforts.

The coral resources at risk from the direct impact from dredging and land reclamation activities for the cruise berthing facility within George Town Harbor includes an estimated 391,001 hard corals and 61,291 soft corals. These estimates are based on calculations of average densities of hard and soft corals from each coral-supporting habitat. Of the 391,001 hard corals at risk, more than 274,000 are less than 10 cm in diameter and relatively young specimens. Similarly, of the 61,291 at-risk soft corals, more than 44,200 are less than 25 cm in height and relatively young specimens. Subsequently, the estimated number of hard corals (>10 cm in diameter) and soft corals (>25 cm in height) that could be considered for translocation is over 116,800 and over 17,000, respectively.

Some apparent differences can be seen between habitat delineation based on ground truthing and the interpretation of side-scan sonar data used to map the distribution of consolidated and unconsolidated substrates (**Figure 6**). These differences emerge because the surveys are conducted at different levels of spatial resolution on a rather heterogeneous landscape. For example, small sand patches present in a landscape dominated by coral-supporting hard bottom may be observed during dive operations but may not be discernable from side-scan sonar imagery. Thus, the randomly selected ground-truthed habitat classification points may have occurred in an area mapped as coral-supporting habitat based on the more generalized sonar classification.

Figure 6. Distribution of coral-supporting habitats within the berthing program's projected direct impact area relative to the interpretation of side-scan sonar data and ground-truth locations.

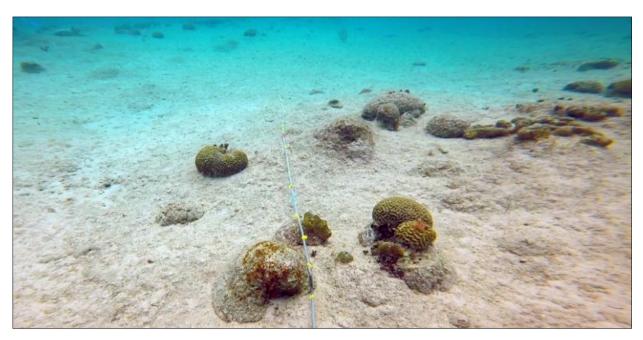
Image 10. Representative image of the hard bottom with sand veneer habitat.

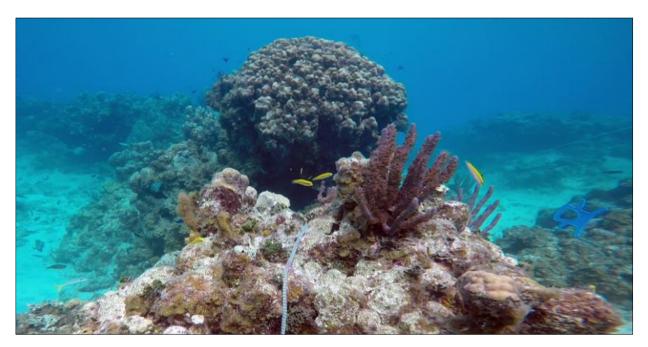
Image 11. Representative image of the exposed reef formation habitat.
