REVIEW OF THE ROYAL CAYMAN ISLANDS POLICE SERVICE RESPONSE TO REPORTS OF MISSING PERSONS AT SEA 6 MARCH 2016

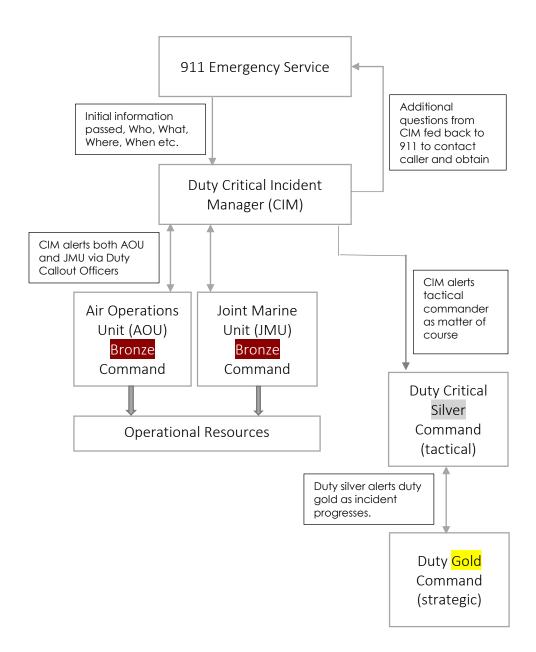
Figure 1 - command, control and coordination

The RCIPS operate a UK emergency services standard model of command and control utilising three levels of command namely Gold, Silver and Bronze [1]

At the outset of an incident the 911 service is the only authority aware of the incident. As such they are the coordinators of the incident.

Once the emergency call details have been passed to the Duty Critical Incident Manager (CIM) he takes over coordination of the incident and assumes coordination and control of the incident.

The CIM contacts the Air Operations Unit (AOU) and Joint Marine Unit (JMU) and delegates the Operational Bronze control to the section commanders who in turn organise their own units. At this stage most of the coordination function in terms of asset dispatch and search planning is done by these Bronze commanders who will organise their own units and also liaise with each other to form a joint response.

The CIM will always contact the Duty Critical Silver Commander who operates at a tactical level. In this review the role of Silver was taken by the rank of Chief Inspector.

At this stage the Duty Silver is the most senior officer to be involved and has a tactical oversight of the incident.

If required the Duty Silver Commander will contact the Duty Gold Commander who will take overall strategic level responsibility for the incident. In this review the role was taken by the rank of Deputy Commissioner of Police.

Whilst the command and control roles shown here are fairly standard the coordination role starts with the 911 service, is passed to the Duty CIM and then passed onto the operational unit heads. A Search and Rescue Mission Coordinator is not clearly defined.

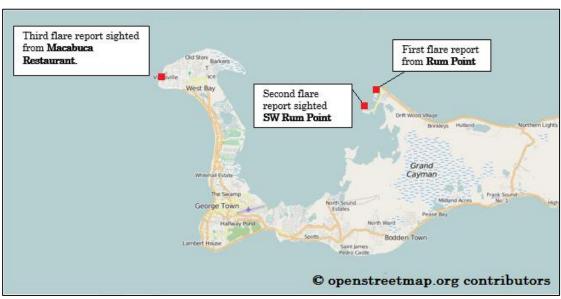
Figure 2 - Map of the West side of Grand Cayman showing the **approximate** location of the three red flares. For illustrative purposes only.

1900 During the coordination of this incident another flare report was received via the emergency 911 service from a member of the public. The caller initially stated that he had seen the flare from his position at Macabuca Restaurant, North West Point (See figure 2) and it had been around three miles offshore in a North West direction. The 911 call handler believing the call to be the same as that in the Rum Point area thanked the caller and closed down the call. She then communicated this report to the Police aircraft which was still hovering in a position around Governor's creek. The aircraft captain upon receiving this new report was able to confirm that a flare on the west side of the island was a different one to that reported earlier. Subsequently the 911 operator called back the first informant for more details and later Police officers were dispatched to speak to the first informant. Upon arrival they were able to determine with a compass and the caller

pointing in the direction he had seen the flare that it probably came more from a South West direction and not North West as he had originally stated. Further questioning indicated that the first informant had sighted a red coloured light for approximately 2-3 seconds falling below the fascia bar of the restaurant. Nothing further had been seen. Meanwhile the Police aircraft began a search of the area using their Forward Looking Infra-Red (FLIR) camera transiting from their position to North West Point and then offshore in a North West direction as had been initially indicated.

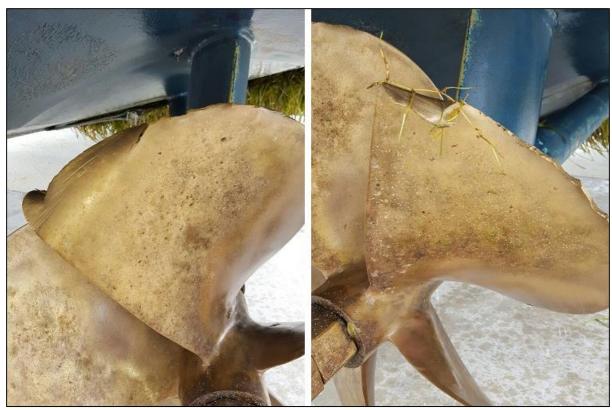
0915 The Cayman Guardian whilst transiting the main channel on route out to the search area reported as taking damage to the propeller on the starboard side (see figure 3). Tide tables for this period indicate the tide should have been nearly high water with levels around 1ft [8] above MLLW [9]. The incident is said to have been caused by excessive wave action causing the vessel to hit the seabed at the trough of the wave. Given the sea conditions and excessive vibration from the starboard side drive area the decision was taken to return the vessel to base, arriving at 1030. The Guardian was subsequently lifted from the water at a local boatyard and a new propeller was fitted. This process took several hours and delayed deployment of the vessel into the search area until the following day.

Figure 3 - Shows the damage to the starboard propeller

1304 With the Cayman Guardian still out of the water having the propeller replaced, two officers from the JMU went aboard a cruise ship tender to try and assist with the search. Not considered safe so plan abandoned.

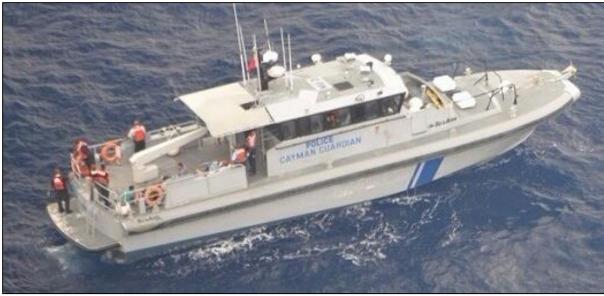
Figure 5 - Marine launch Cayman Guardian

- The Forward Looking Infra-Red system fitted to the Cayman Guardian was defective and had been for some time. The Radar system was described as ineffective which thus meant that the crew would have been relying on a visual search with no moonlight in rough seas.

- Equipment was also highlighted during this review. The Cayman Guardian reportedly has an issue with one of its fuel tanks which leaks fuel into the surrounding compartment space. Aside from the other issues with fuel leaking and moving around this also means the crews have to contend with a very strong and often nauseous smell of diesel whilst they are at their lookout positions in the upper part of the vessel. The FLIR camera is currently unserviceable and the radar system is described by the marine commander and Chief Inspector of the Marine unit as inefficient. Limitations with equipment such as this can hinder efficient operation. These defects should if possible be rectified to ensure that when crews put to sea they have the very best chance of a successful mission. A second vessel which is highly rated by the crew as being a stable and good search platform currently sits alongside and was reported as having sufficient defects to restrict its operation.
